## The Architecture and Function of the Stadium of Kibyra

F. Eray DÖKÜ – M. Can KAYA\*

The first aim of this study is to examine the architectural details and the problems of the stadium which was the most magnificent building constructed in Kibyra during the Roman period. It is also a study of the function of the stadium, its place within the city's urban fabric, its typological importance among Anatolian stadiums during the Roman period, its dating from evidence provided by inscriptions and small finds, and finally a discussion of two differing opinions concerning the interpretation of the traces of earthquake. This is, in part, the result of archaeo-seismological studies and evidence for which can be seen clearly in the area.

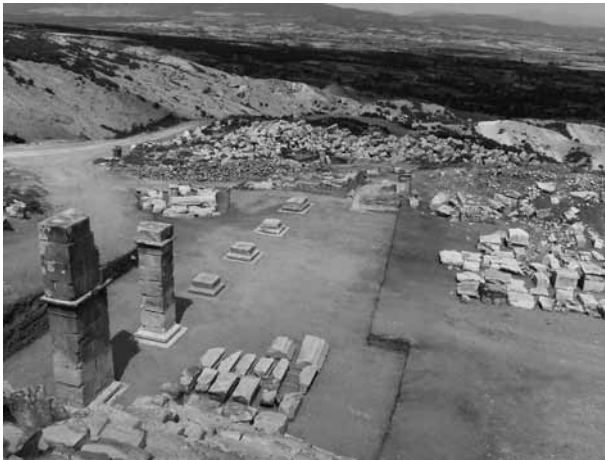
Fig. 3  
Propylon of stadium  
after excavation.

The stadium of Kibyra is entered through a propylon consisting of five arched entrances (Figs. 3-5). When considered as to plan, it is distinguished among other Roman-period stadiums through its single sphendone U form, which is the most common form in Anatolia. It is different than the double sphendones in Laodicea<sup>21</sup> and nearby Aphrodisias<sup>22</sup> (Figs. 5, 6). Moreover, it has a different plan from those stadiums that are one sided and lean into the slopes of hills such as the stadiums at Tlos<sup>23</sup>, Arykanda<sup>24</sup> and Kadyanda<sup>25</sup> in Lykia, the southern neighbour of this region. Although associations can be drawn between the stadium of Kibyra and those of Ephesus<sup>26</sup>, Magnesia at Meandrum<sup>27</sup>, Perge<sup>28</sup>, Aspendos<sup>29</sup>, Sillyon<sup>30</sup>,

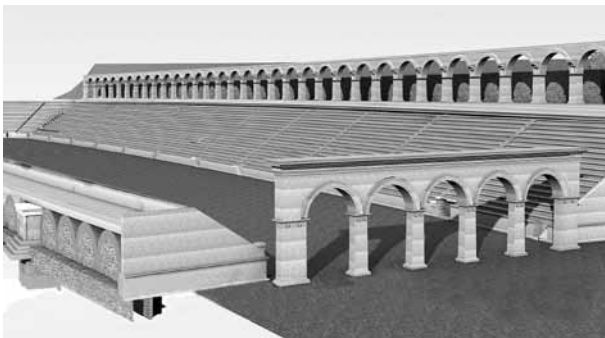
Fig. 4  
Propylon building of  
stadium and Hellenistic  
monumental tomb in  
eastern retaining wall  
(Architects I. Akgül –  
N. Gürlesin – M. Sayan –  
N. Kocaman).

The ingress and egress of the spectators and athletes into the stadium was provided by three doors (Figs. 4, 6). The first is the monumental propylon located in the north. It was the main gate facing the city. The other door was opposite the seats of honour in the middle of the western rows of seats through which the athletes came on to the field and saluted the dignitaries. The third door was the vaulted one at the southern end and located in the middle of the sphendone. Thus comfortable entry and exit for the crowds of spectators was provided through both ends of the north-south-orientated stadium.

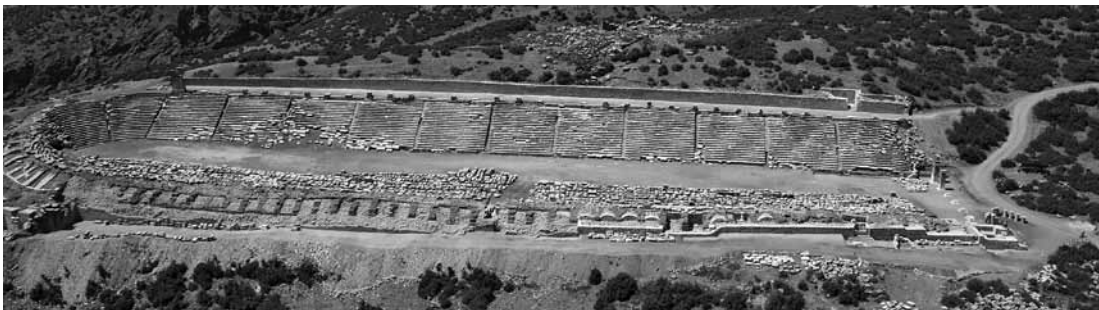
Fig. 5 Aerial photograph of stadium.

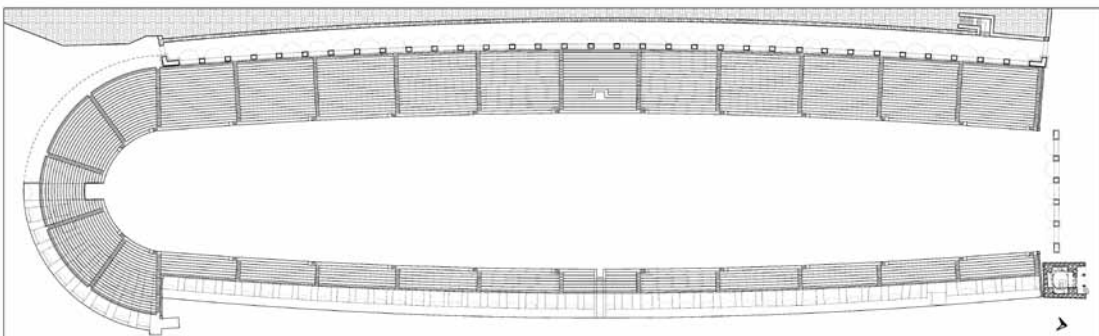
Fig. 6 Plan of stadium (Architects I. Akgül – N. Gürlesin – M. Sayan – N. Kocaman).

The portico, which stood over the western rows of seats, would have been covered with a wooden roof and provided a monumental façade to the stadium (Figs. 4-6, 10, 12). This structure achieves the architectural aim of suggesting a holistic appearance, given its similarity to the monumental gate providing entry at the north. The total height of the portico is about 6 m.; it is elevated over plinths placed every 4 m. and linked by arches. The dedicatory inscription along the upper blocks of the portico can be traced along its whole length. The length of the inscription - only 40 m. of its 70 m. length was found during the excavations - again stresses

Another area related to the stadium is a late building formed from spolia blocks at the south-east end of the stadium. It was discovered and exposed during excavations in the 2009 season. This building is a two-storey monumental tomb built from rubble stone and lime mortar with an *in antis* plan. Two different reused column bases at the entrance in the middle of the ante walls of the building have been protected until today. While the main room of the two-storey building was supported by vaults placed on four sides of the room below, the lower floor was employed as a burial chamber. In the arcosolium on the east there is a rectangular chamasonry cut into the main rock. As a result of the excavation work, it was determined that this building measuring 8.70 x 7.30 m. can be dated to the 6<sup>th</sup>-7<sup>th</sup> centuries A.D. It is thought to be a monumental tomb in temple form, such as a Martyrion<sup>37</sup> (Figs. 6, 13).

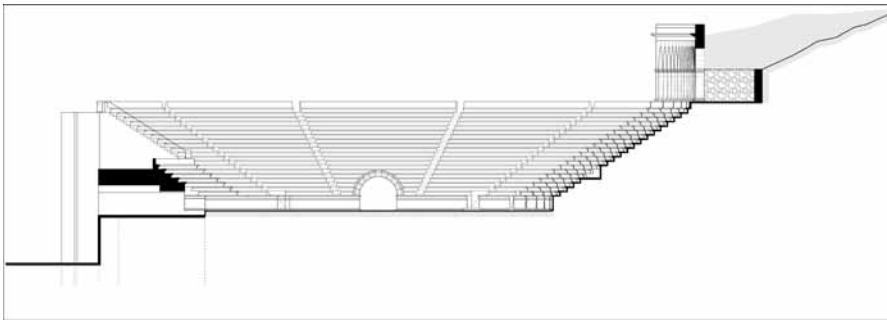
Fig. 7  
Cross-section of  
21 rows of seats  
extending to end  
of sphendone  
arch (Architects  
I. Akgül –  
N. Gürlesin –  
M. Sayan –  
N. Kocaman).

the eastern cavea (Figs. 5-8). During the studies carried out in 2009 to determine the wall at the south end of stadium upon which the eastern seats rest, we found that the sphendone was supported by two vaults averaging 3.35 m. wide and 10 m. high alongside the sphendone's semi-circle. When forming these vaults with blocks cut from the main rock inside, one outer row was hidden by smoothly cut limestone blocks (Figs. 9-10). Most probably the bed-rock revealed when leveling the hill during building of the stadium was cut into blocks and used to construct the vaults at the rear of all the eastern seating. However, because this conglomerate main rock is not a particularly good building material strong enough to support the vault, it was filled with mortars and stones in order to strengthen it (Figs. 9-11 a-c).

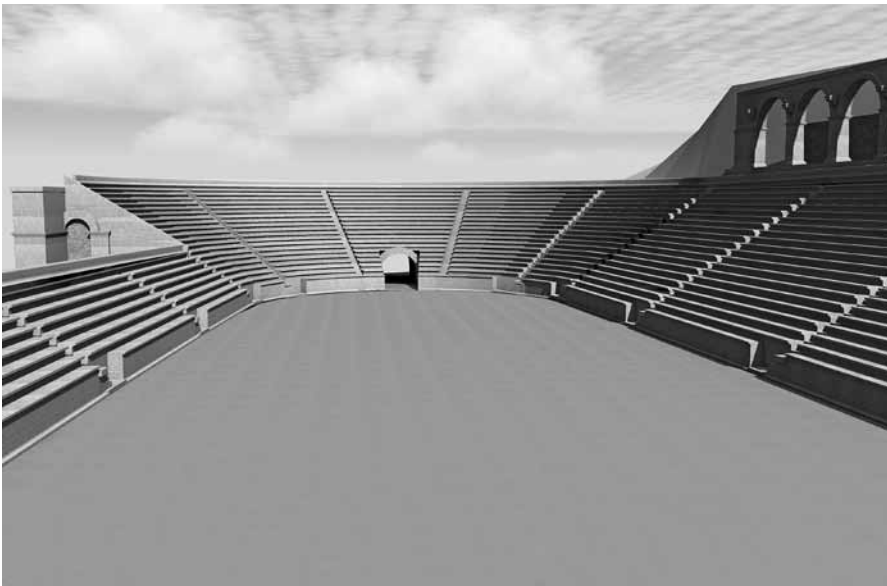
Fig. 8  
3-D View of 21  
rows of seats  
extending to end  
of sphendone arch  
(Architects I. Akgül –  
N. Gürlesin –  
M. Sayan –  
N. Kocaman).

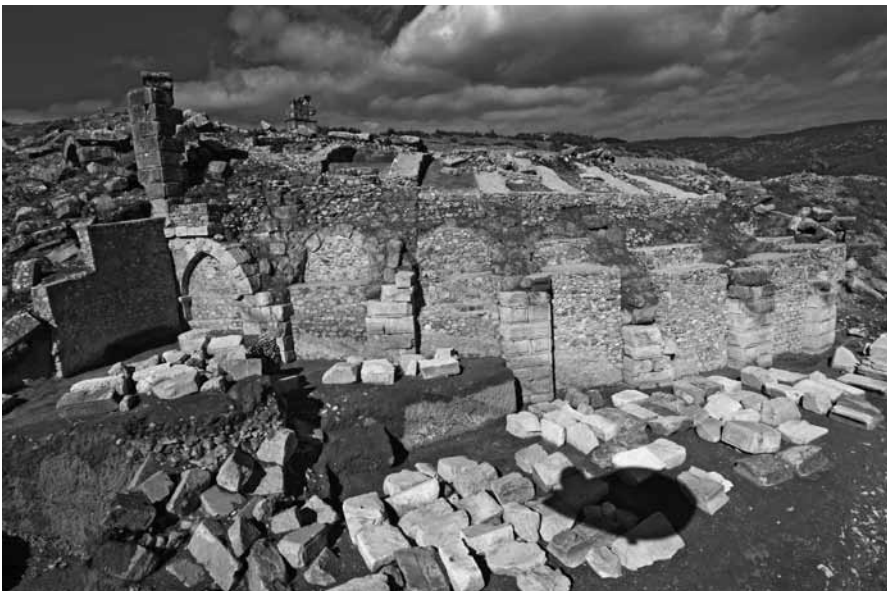
Fig. 9  
Sphendone vaulted  
arch support for  
south-eastern  
two-storey  
retaining wall.

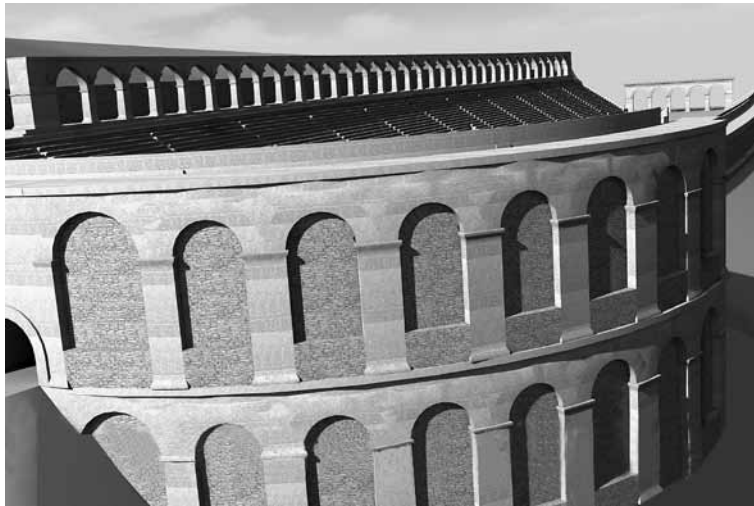
Fig. 10  
Sphendone vaulted arch  
support for south-eastern  
two-storey retaining wall  
(Architects I. Akgül –  
N. Gürlesin – M. Sayan –  
N. Kocaman).

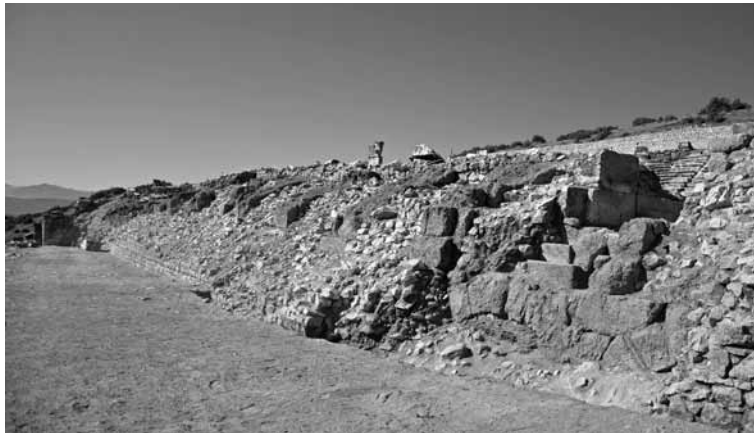
Fig. 11a  
Eastern gate and vaults of  
two-storey retaining wall.

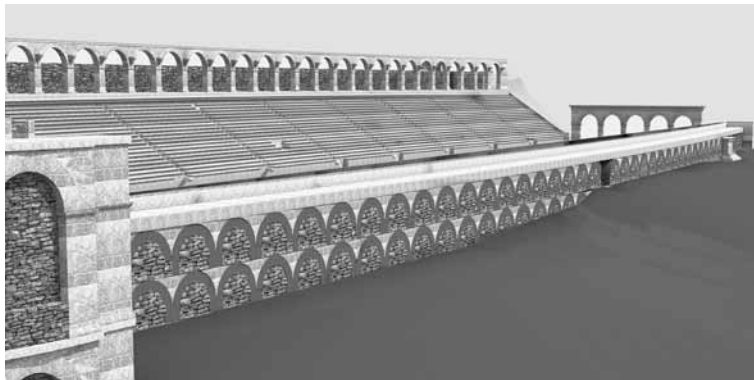
Fig. 11b  
Eastern gate and vaults of  
two-storey retaining wall  
(Architects I. Akgül –  
N. Gürlesin – M. Sayan –  
N. Kocaman).

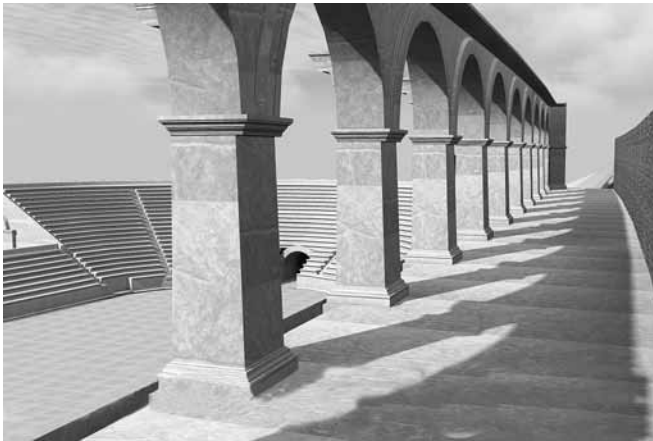
Fig. 12  
Stadium's porticus area  
(Architects I. Akgül –  
N. Gürlesin – M. Sayan –  
N. Kocaman).

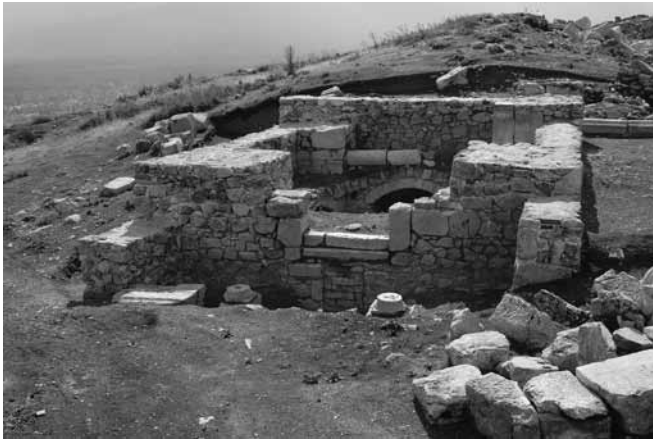
Fig. 13  
Martyrion north  
of stadium.

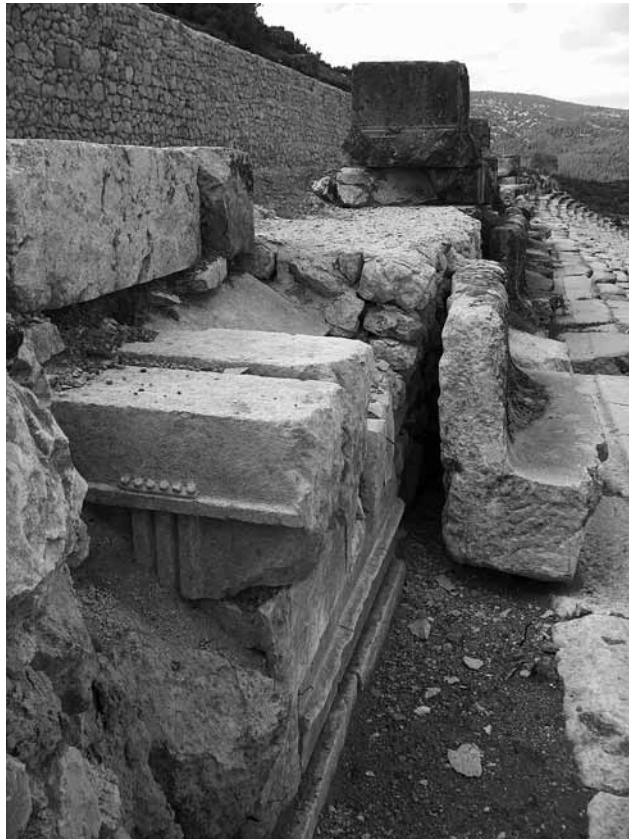
Fig. 16 Spolien material re-employed in the foundations of the Portico bases on the west seating rows of the stadium.

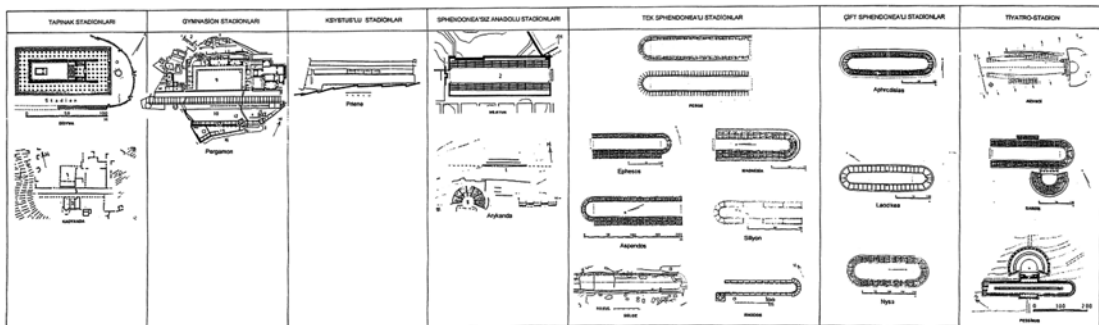
Fig. 17 Typology of Anatolian stadiums (Ilhan 1996, Fig. 82).

Stadium buildings became more common in Anatolia in the Hellenistic era and especially during the period of the Roman Empire. This increase in number also saw the combination of functions with stadiums being not only the places for athletics, but also arenas employed for gladiatorial fights<sup>59</sup>. N. İlhan has established the functional and architectural typology of the Anatolian stadiums known to the present day (Fig. 17).

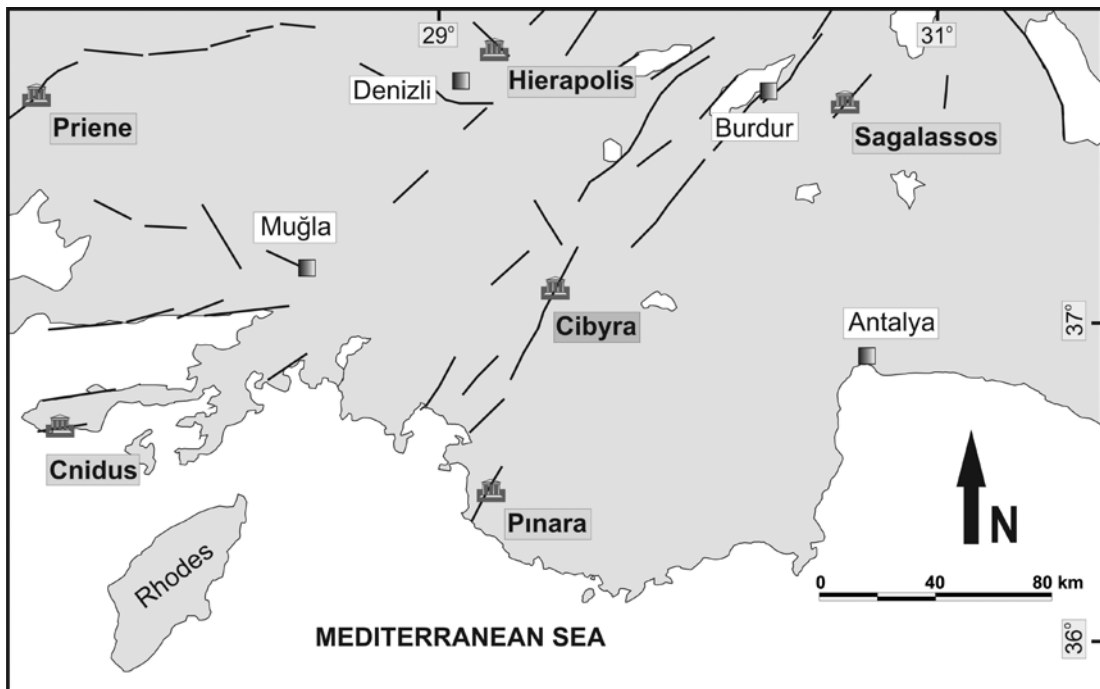
Fig. 18  
Major active faults and  
the location of some  
of the ancient cities in  
southwestern Turkey  
(Karabacak et al. 2009,  
Fig. 1.1.b; Karabacak  
2011, Fig. 1).

South-western Turkey is rich in well-exposed archaeological sites which today preserve damage caused by historical earthquakes (e.g. Priene, Hierapolis, Knidos, Sagalassos, Pinara, Aspendos, Side, Cremna, Selge, etc.). Kibyra was damaged at times by earthquakes because of its location on the Fethiye-Burdur fault zone that formed a secure corridor extending to the Mediterranean. The city's stadium, sited on a north-north-east trending fault zone, especially provides evidence of severe seismic destruction. Kibyra was destroyed by an earthquake in A.D. 23 and restored with help from the emperor Tiberius<sup>71</sup>. According to Guidoboni et al., the A.D. 417 earthquake also occurred in this fault zone and so seriously damaged Kibyra<sup>72</sup>. With most recent studies, Akyüz and Altunel (2001) stated that the earthquake in 417 happened on the fault line running through the stadium causing a surface break. There are no reports of other earthquakes after the city was abruptly abandoned following this event in 417<sup>73</sup>. However, based upon detailed field observations Karabacak (2010) has suggested that a later large earthquake caused extensive damage in Kibyra probably after the 7<sup>th</sup> century A.D. (Figs. 18-21).

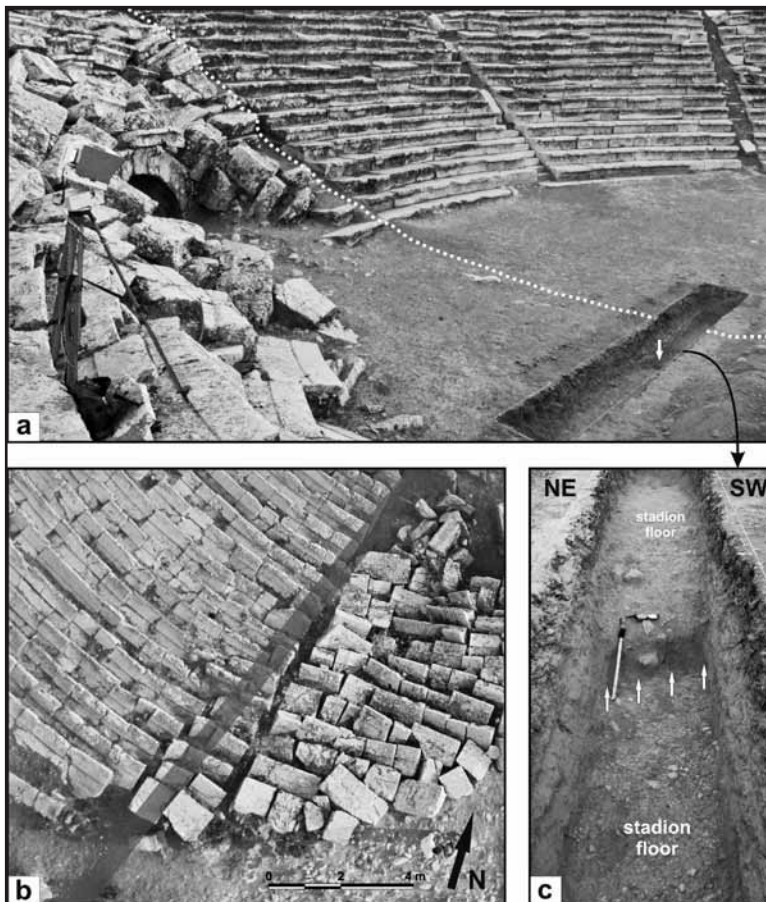
Fig. 19  
a. Faulting at the  
southern entrance  
to the Kibyra stadion.  
b. Aerial photo from  
seat rows.  
c. The archeological  
excavation of the probable  
rupture extension.  
Deformation is obvious  
on the stadion floor,  
made of compressed  
limestone pebbles on  
the flattened  
bed-rock (red lines  
and arrows show the  
fault) (Karabacak et al. 2009,  
Fig. 4.20 a-c; Karabacak 2011,  
Fig. 10 a-c).

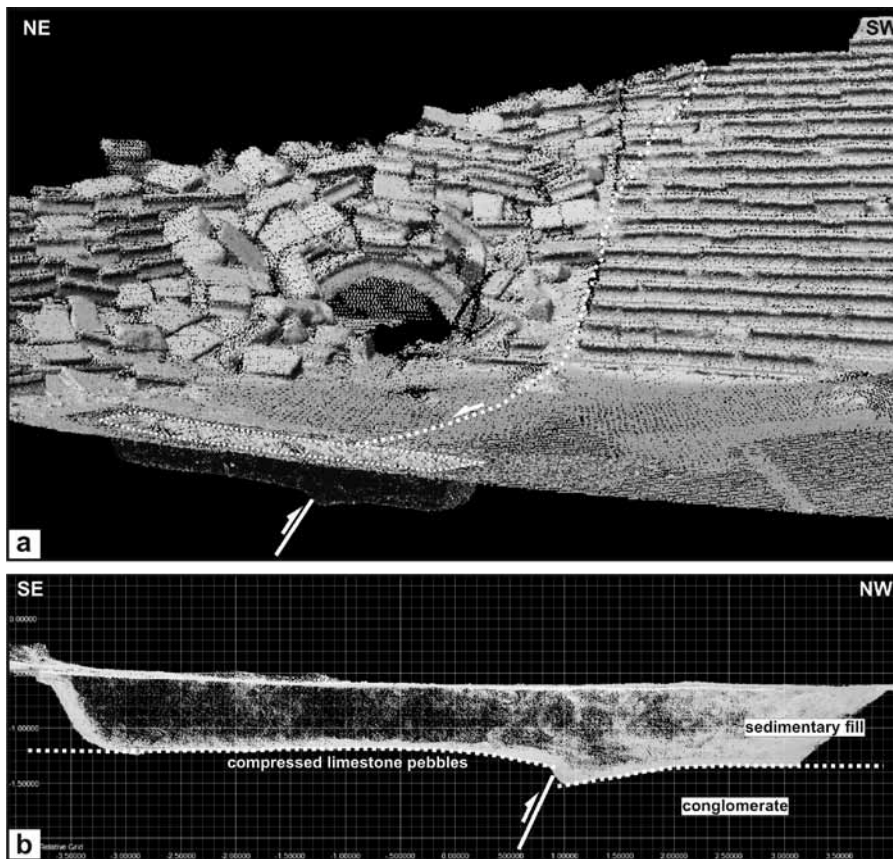
Fig. 20  
a. LIDAR studies on the southern entrance to the Kibyra stadium.  
b. Cross section through the buried stadium floor obtained by LIDAR measurements which indicates the amount of vertical displacement. (red lines and arrows show the fault) (Karabacak et al. 2009, Fig. 4. 21 a, d; Karabacak 2011, Fig. 11 a-d).

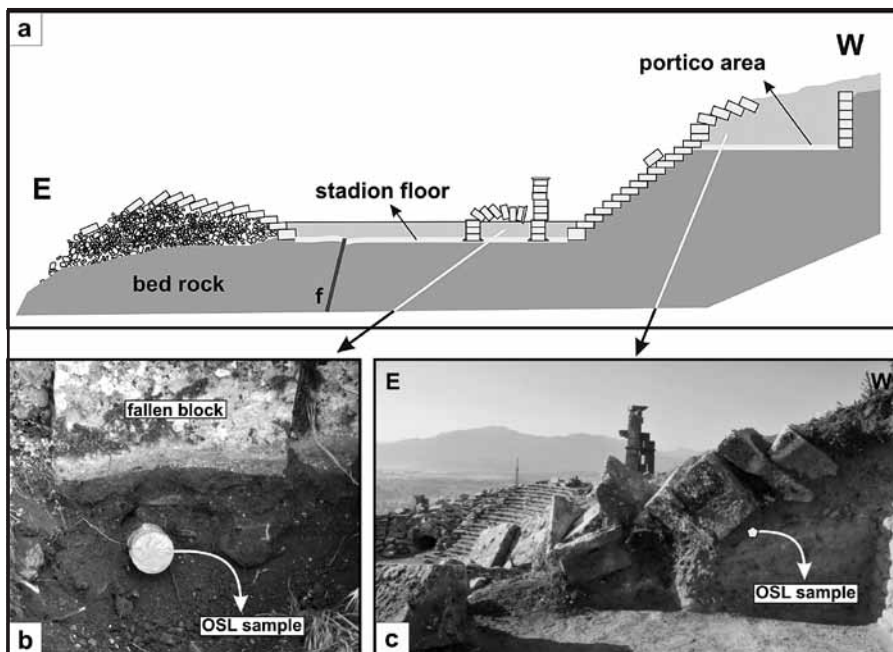
Fig. 21  
a. Model of the Kibyra stadium, which schematizes the earthquake-related deformations in the same section, not drawn to scale. (f: fault rupture).  
b. A fallen block of the northern entrance column and OSL sampling below it. c. The side columns of the portico area have fallen towards the west in domino-slice of salami style upon the sedimentary deposit. (Karabacak et al. in press).

Karabacak proved from archaeoseismological data that the stadium was damaged by various earthquakes over time. The most revealing data concerns the fault running through the seats of the stadium. Traces of the surface break have been proved in the course of excavation and through microtopographic LIDAR (Fig. 20) measurements, whereas shallow geophysical studies have been used for deep traces. In the stadium the damage related to seismic shaking are the blocks of columns fallen in domino-style towards the west (Fig. 6). Detailed archaeoseismological surveys have shown that the stadium was devastated by an earthquake in the 5<sup>th</sup> century A.D. (most probably the earthquake of A.D. 417) that caused a surface break<sup>74</sup>. The stadium floor and the eastern rows of seats must have been so damaged that the stadium could not be used for its original purpose after this date. The seats were not restored after this earthquake; the surface break on the stadium floor and the portico covered with dense sedimentation are the proof for this. The dating of the collapsed blocks using the OSL method shows that another earthquake occurred probably around the 10<sup>th</sup> or 11<sup>th</sup> centuries A.D. However, the stadium was not in use then but further extensive damage was still dealt to its remains (Fig. 21).

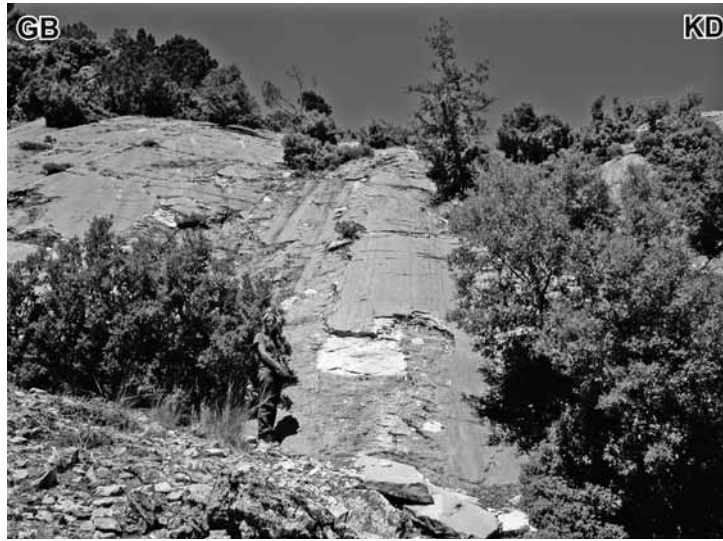
Fig. 22  
Photo of the  
Kibyra fault line  
(Elitez – Yaltırak  
2012).

Elitez and Yaltrak, on the other hand, suggest that the above-mentioned fault line does not pass through the stadium, and the deformation supposedly caused by the fault line was instead caused by the lateral expansion caused by the seismic wave (Figs. 22-25)<sup>75</sup>. They conclude that the destruction of the stadium was certainly caused by an earthquake. But when the geological data is considered, they find no valid evidence that the fault line causing the earthquake passed through the stadium. On the contrary, the character of the destruction with its rotation and domino effect points to the clearly observed fault lying 2.5 km. west of the stadium, and this fault has been mapped with its data (Figs. 23-25). Moreover, when the level of the fault plane and the depth of the earthquake are considered, the epicenter should have been somewhere to the west of Lake Gölhisar. It is thought that this would be sufficient to explain the damage to the fill area over a wide area<sup>76</sup>.

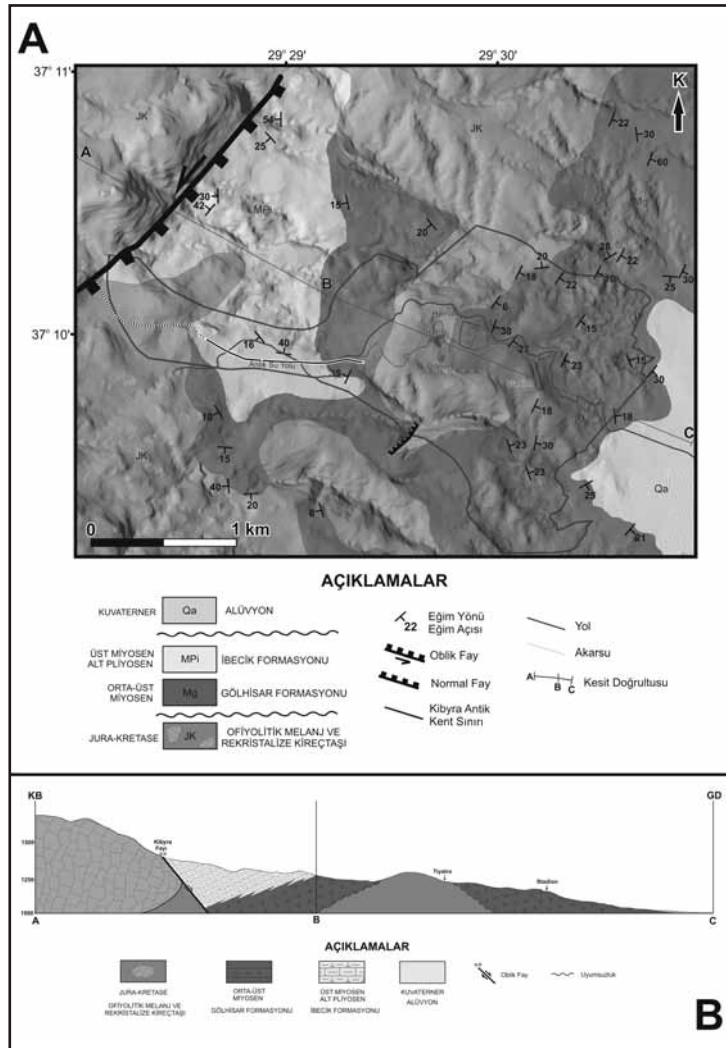
Fig. 23  
The geological  
map (A) and  
cross-section (B)  
of Kibyra  
(Elitez – Yaltırak  
2012)

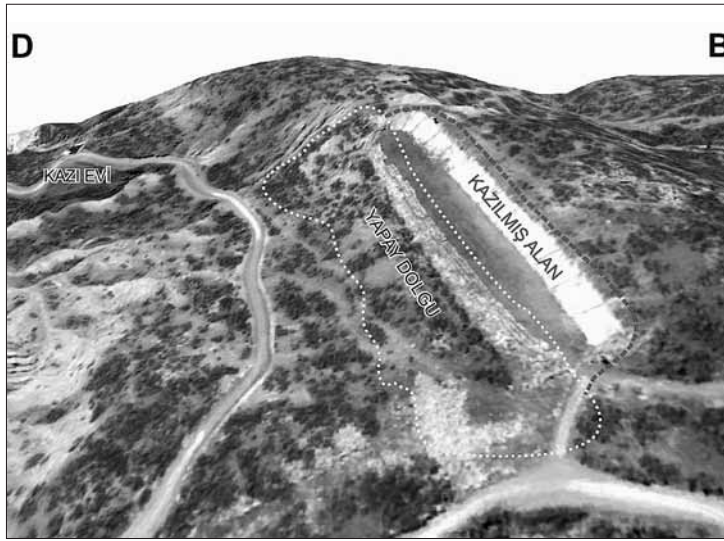
Fig. 24  
The combination of the satellite image and digital elevation model of the stadium and the approximate situations of excavated and artificial fill areas (Elitez – Yaltırak 2012).

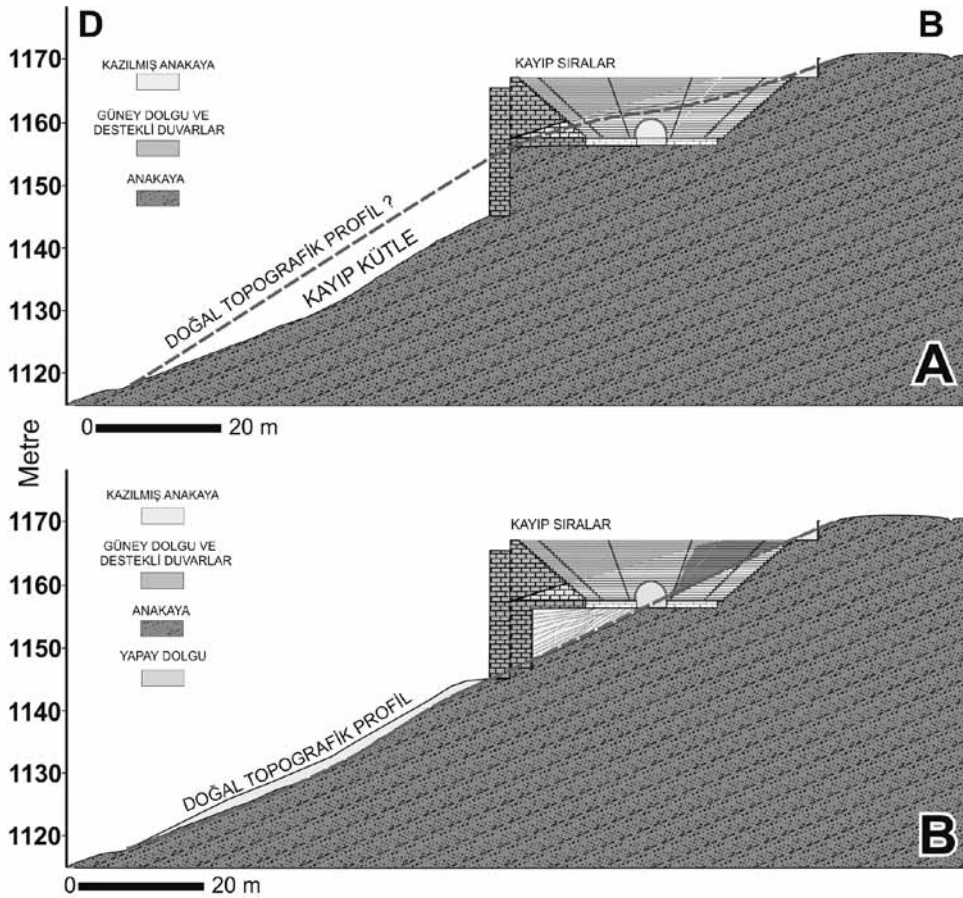
Fig. 25 The real scaled topographic profile of the hill where the stadium located and the situation of the southern seat rows.

A: The stadium is completely on the bedrock. B: The western side of the stadium is on the bedrock and the southern side is on the artificial fill (Elitez – Yaltırak 2012).
